**Water Absorption Dye Test:**

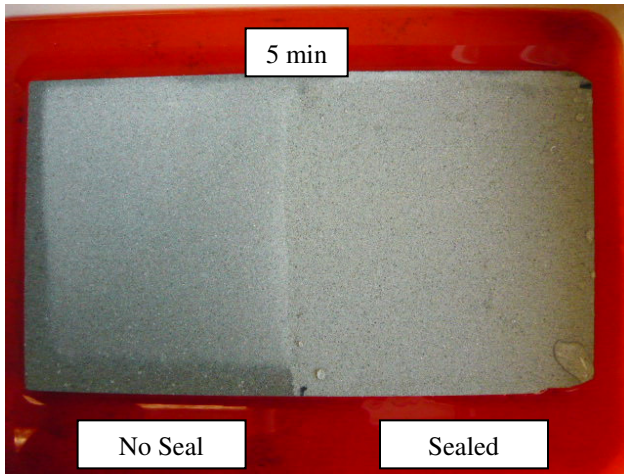
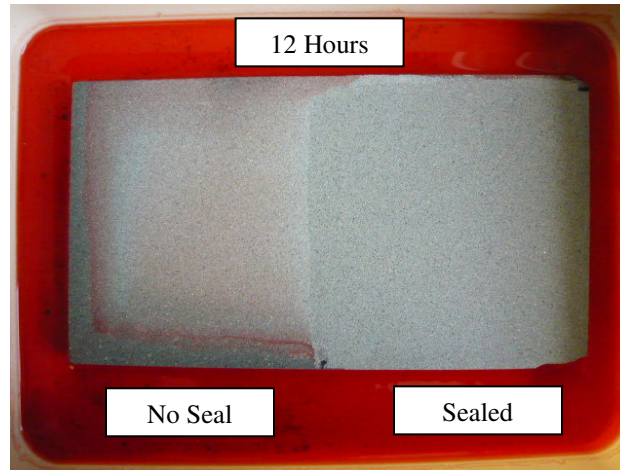
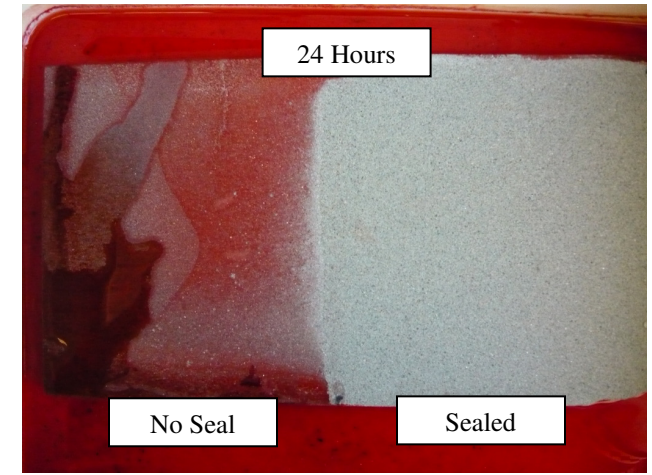
Over a 48 hr period we left this piece of sandstone sitting in a basin of water, with red dye added. The left hand side of the sandstone was left unsealed, and the right hand side was pre sealed on both sides with Solutions Sealers **Consolidate**, and then sealed on the top side with our commercial grade sealer **Quantum**.

As you can see above after 48hr the non sealed area has been completely stained red.

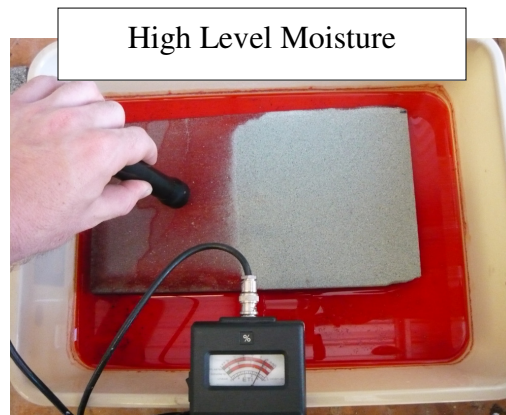
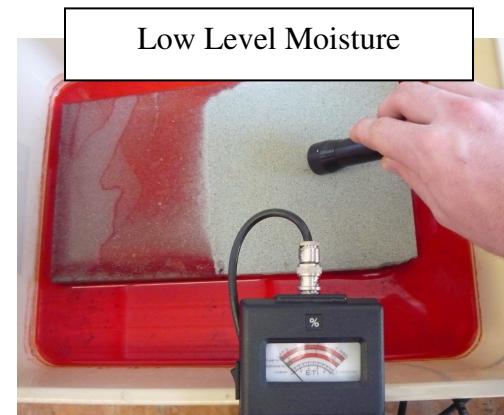
From the pictures shown above, the unsealed area has high levels of moisture. But when testing the sealed area, we discovered no moisture was apparent.
